AIRCRAFT FUELING SYSTEM

DATE: 110C91  
DRAWN BY: JHP  
CHECKED BY: CRT  
FAA AIP NO. X  
WORK BREAKDOWN NO. 14F BB  
DESIGN CONTRACT NO. E 361A  
CONSTR. CONTRACT NO. F361A  
PROJECT NO. 90-203  
VOLUME NO. 1  
SHEET TITLE  
CONC. "A" & "B"  
ELEC. LAYOUT  
SHEET NO. E12.07  
CADD FILE NO. DF  
X14FBBE361AF361A1E12076  
CADD LAYER NAMES

DATE: 110C91  
DRAWN BY: JHP  
CHECKED BY: CRT  
FAA AIP NO: X  
WORK BREAKDOWN NO: 14FBB  
DESIGN CONTRACT NO: E361A  
CONST. CONTRACT NO: F361A  
PROJECT NO: 90-203  
VOLUME NO: 1  
SHEET TITLE  
CONC. "A" & "B"  
ELEC. LAYOUT

DATE: 110C91  
DRAWN BY: JHP  
CHECKED BY: CRT  
FAA AIP NO. X  
WORK BREAKDOWN NO. 14FB  
DESIGN CONTRACT NO. E361A  
CONSTR. CONTRACT NO. F361A  
PROJECT NO. 90-203  
VOLUME NO. 1  
SHEET TITLE  
CONCOURSE "C"  
ELEC. LAYOUT  
SHEET NO. E12.09  
OF  
CADD FILE NO. X14FBBC361AF361A1E120903  
CADD LAYER NAMES

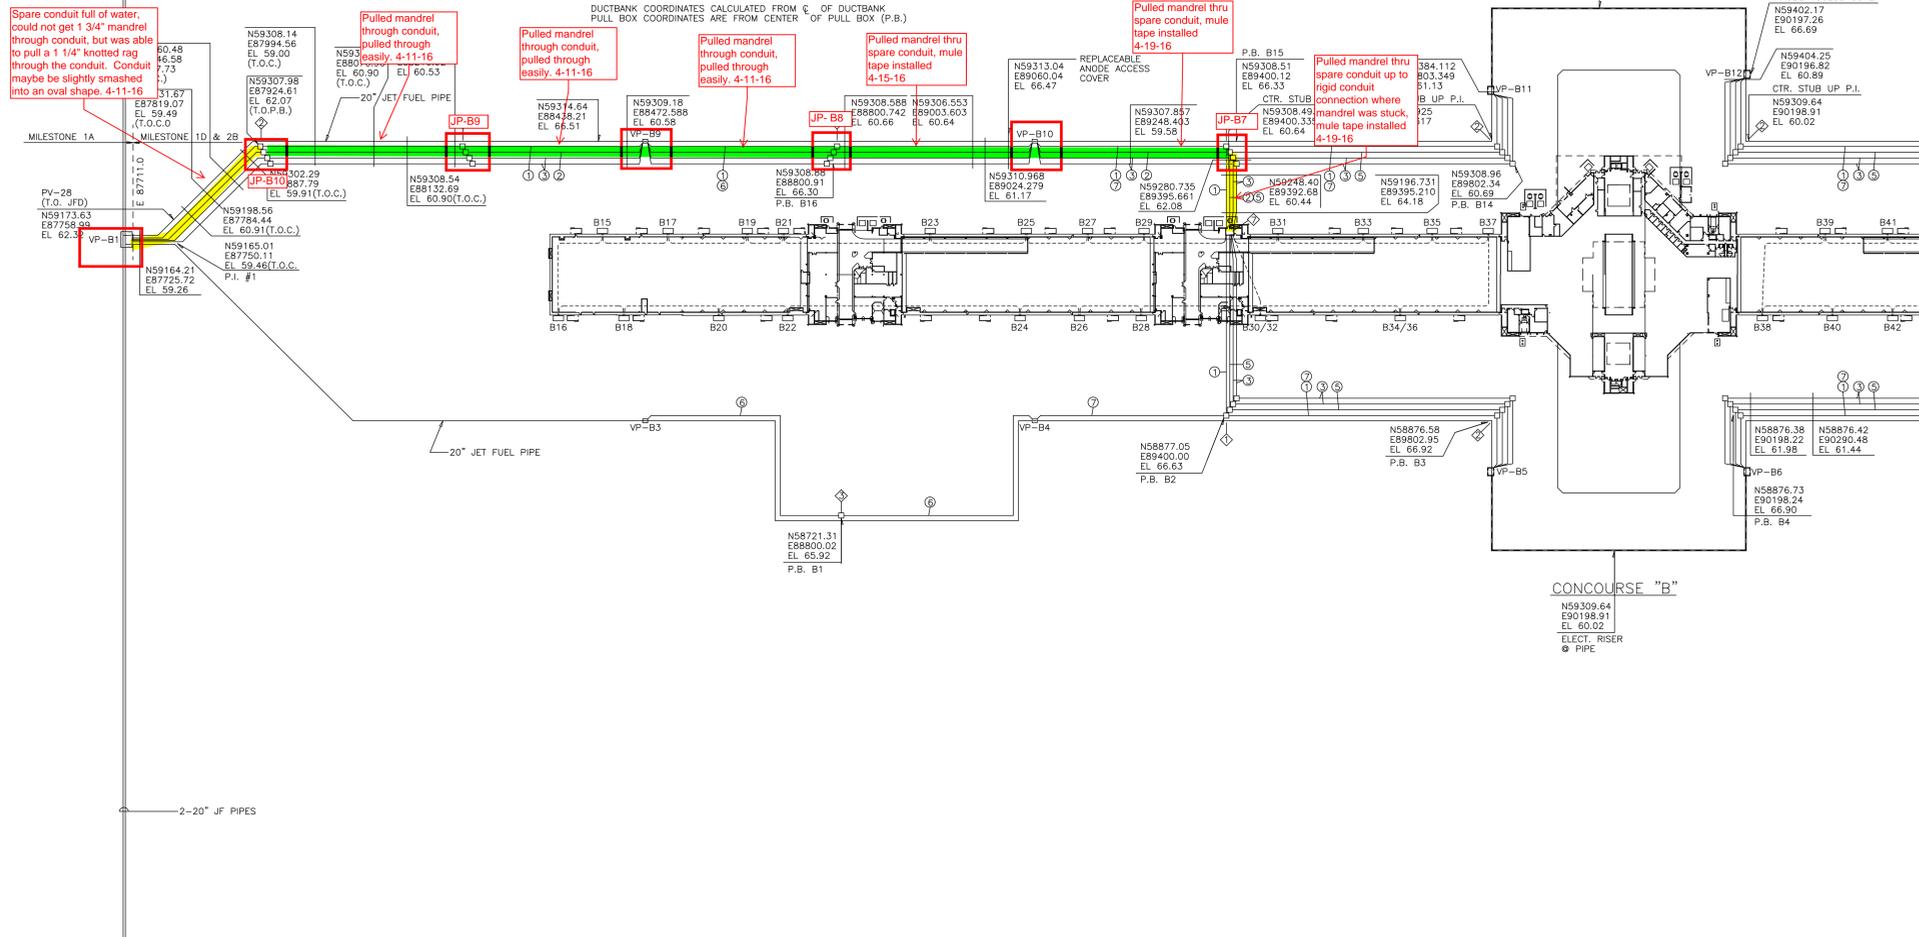
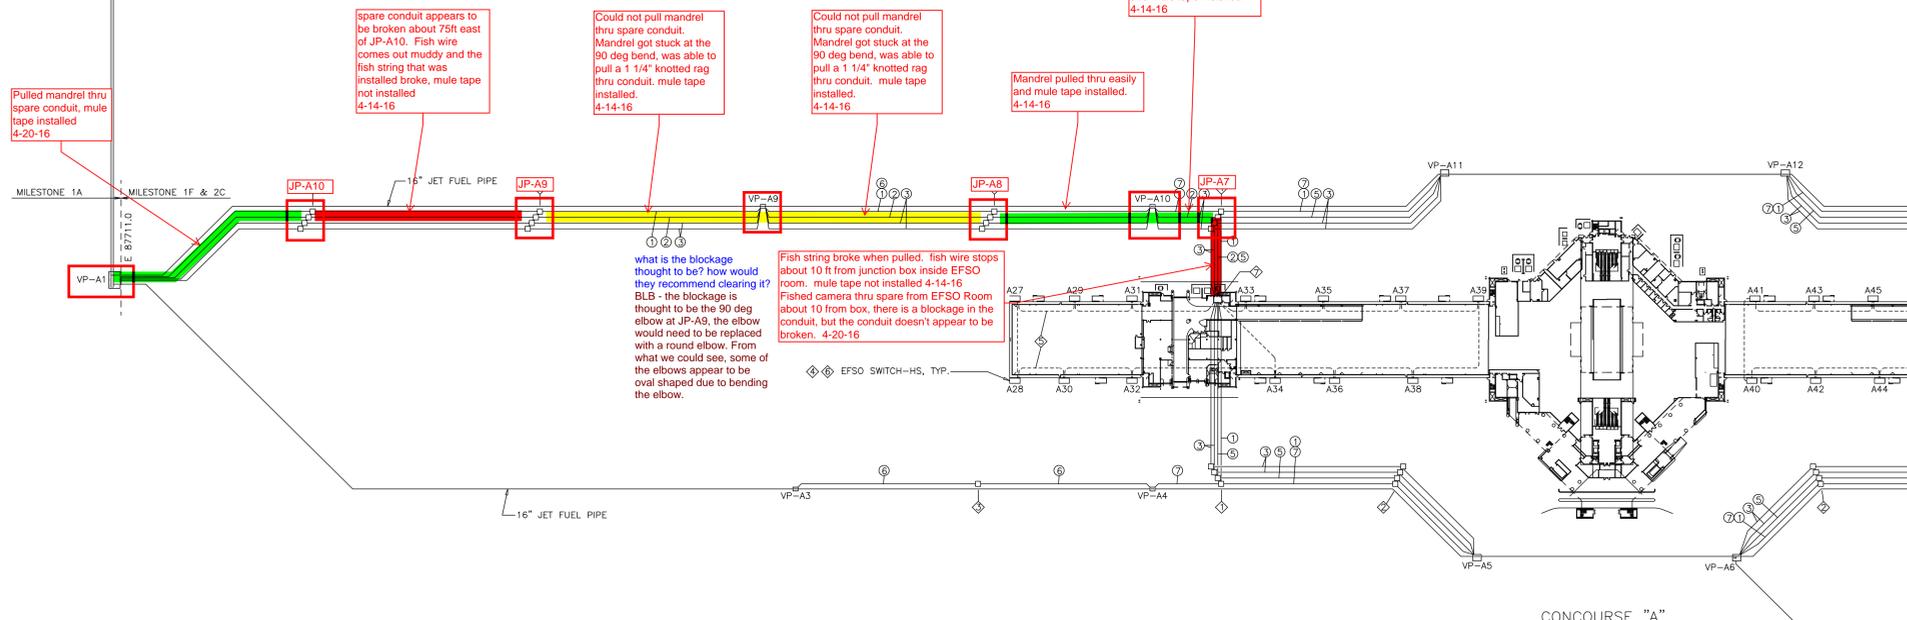
did they pull out the 120v cables? did they try putting the camera in? BLB-No camera, did not have access to this area at the time. No. 120 V was not pulled due to not having enough time.

where is this rigid conduit connection located? BLB - the rigid connector is located in the EFSO Room

conduit might be useable  
conduit not useable  
conduit is useable

did they pull out the 120v cables?  
BLB - 120V was not pulled

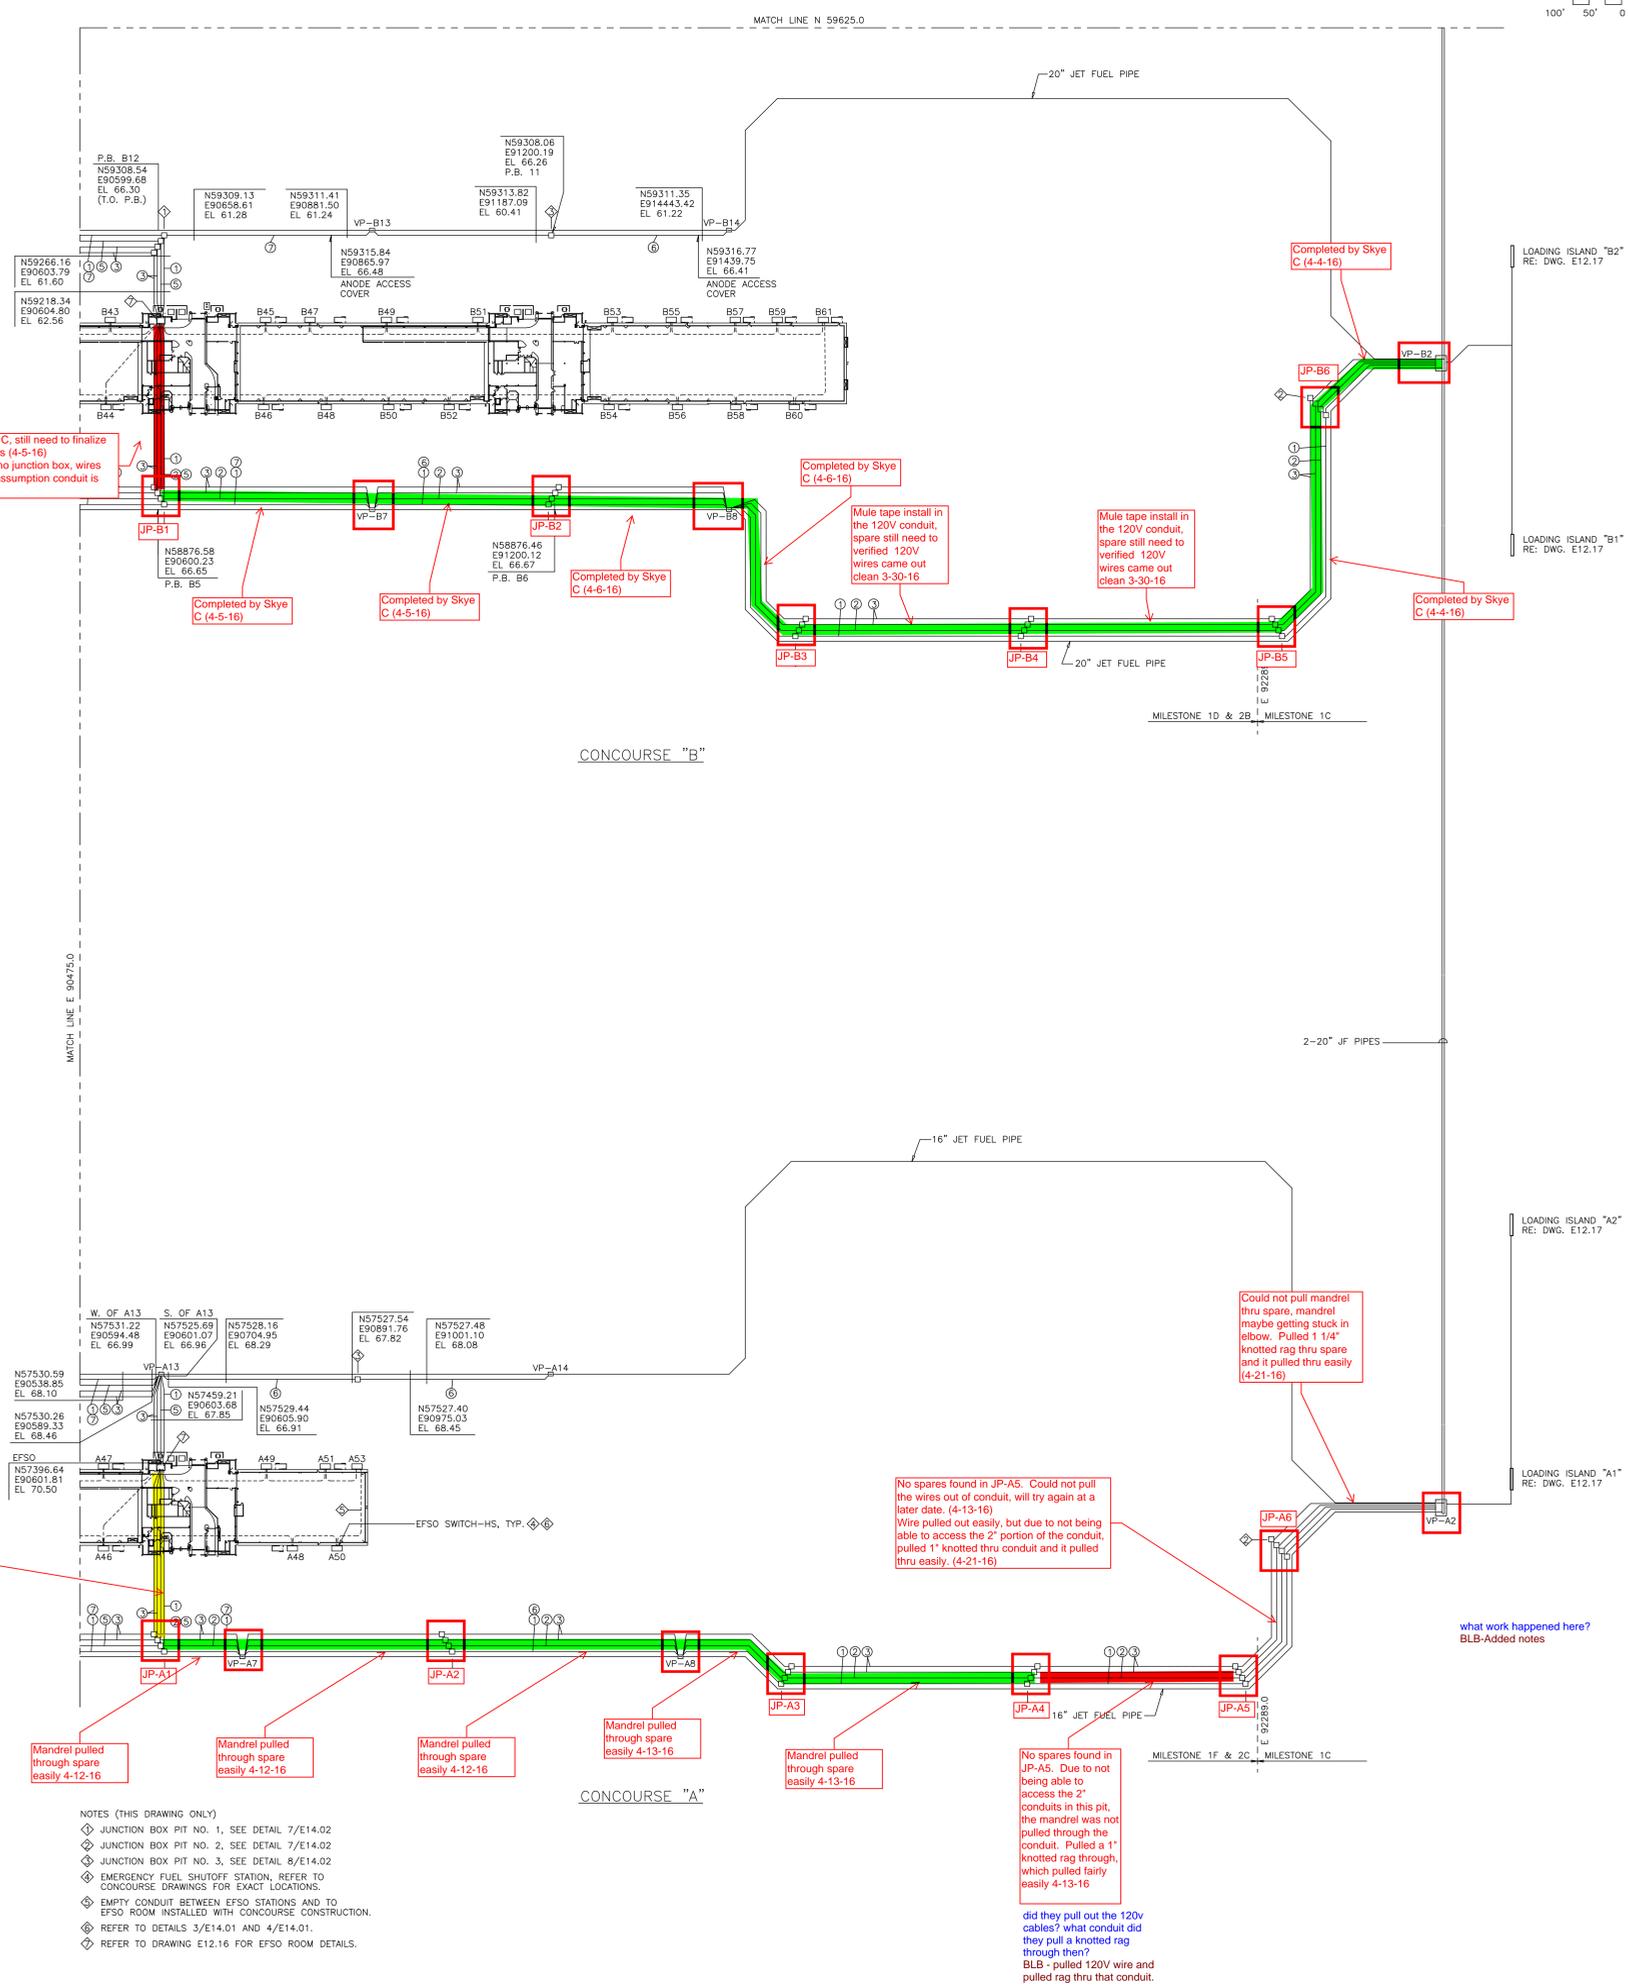
SHEET NO.  
E12.08  
OF  
CADD FILE NO.  
X14FBBC361AF361A1E120803  
CADD LAYER NAMES

Work done by Skye C. still need to finalize work about 1.5 hours (4-5-16)  
Walked basement, no junction box, wires would not pull out, assumption conduit is smashed (4-20-16)

Mule tape install in the 120V conduit, spare still need to verified 120V wires came out clean 3-30-16

did they check this with a camera?  
BLB - did not camera item 2.

Found junction box in basement  
1st - Pulled mandrel from pit to junction box in basement, mandrel pulled through easily  
2nd - Tried to pull mandrel through conduit from junction box to EFSO room, the 1 3/4" mandrel would not pull through, so tried an 1 1/4" knotted ragged and it pulled through easily. In the basement. 4-12-16

Mandrel pulled through spare easily 4-13-16

No spares found in JP-A5. Could not pull the wires out of conduit, will try again at a later date. (4-13-16)  
Wire pulled out easily, but due to not being able to access the 2" portion of the conduit, pulled 1" knotted thru conduit and it pulled thru easily. (4-21-16)

Could not pull mandrel thru spare, mandrel maybe getting stuck in elbow. Pulled 1 1/4" knotted rag thru spare and it pulled thru easily (4-21-16)

did they pull out the 120v cables? what conduit did they pull a knotted rag through then?  
BLB - pulled 120V wire and pulled rag thru that conduit.

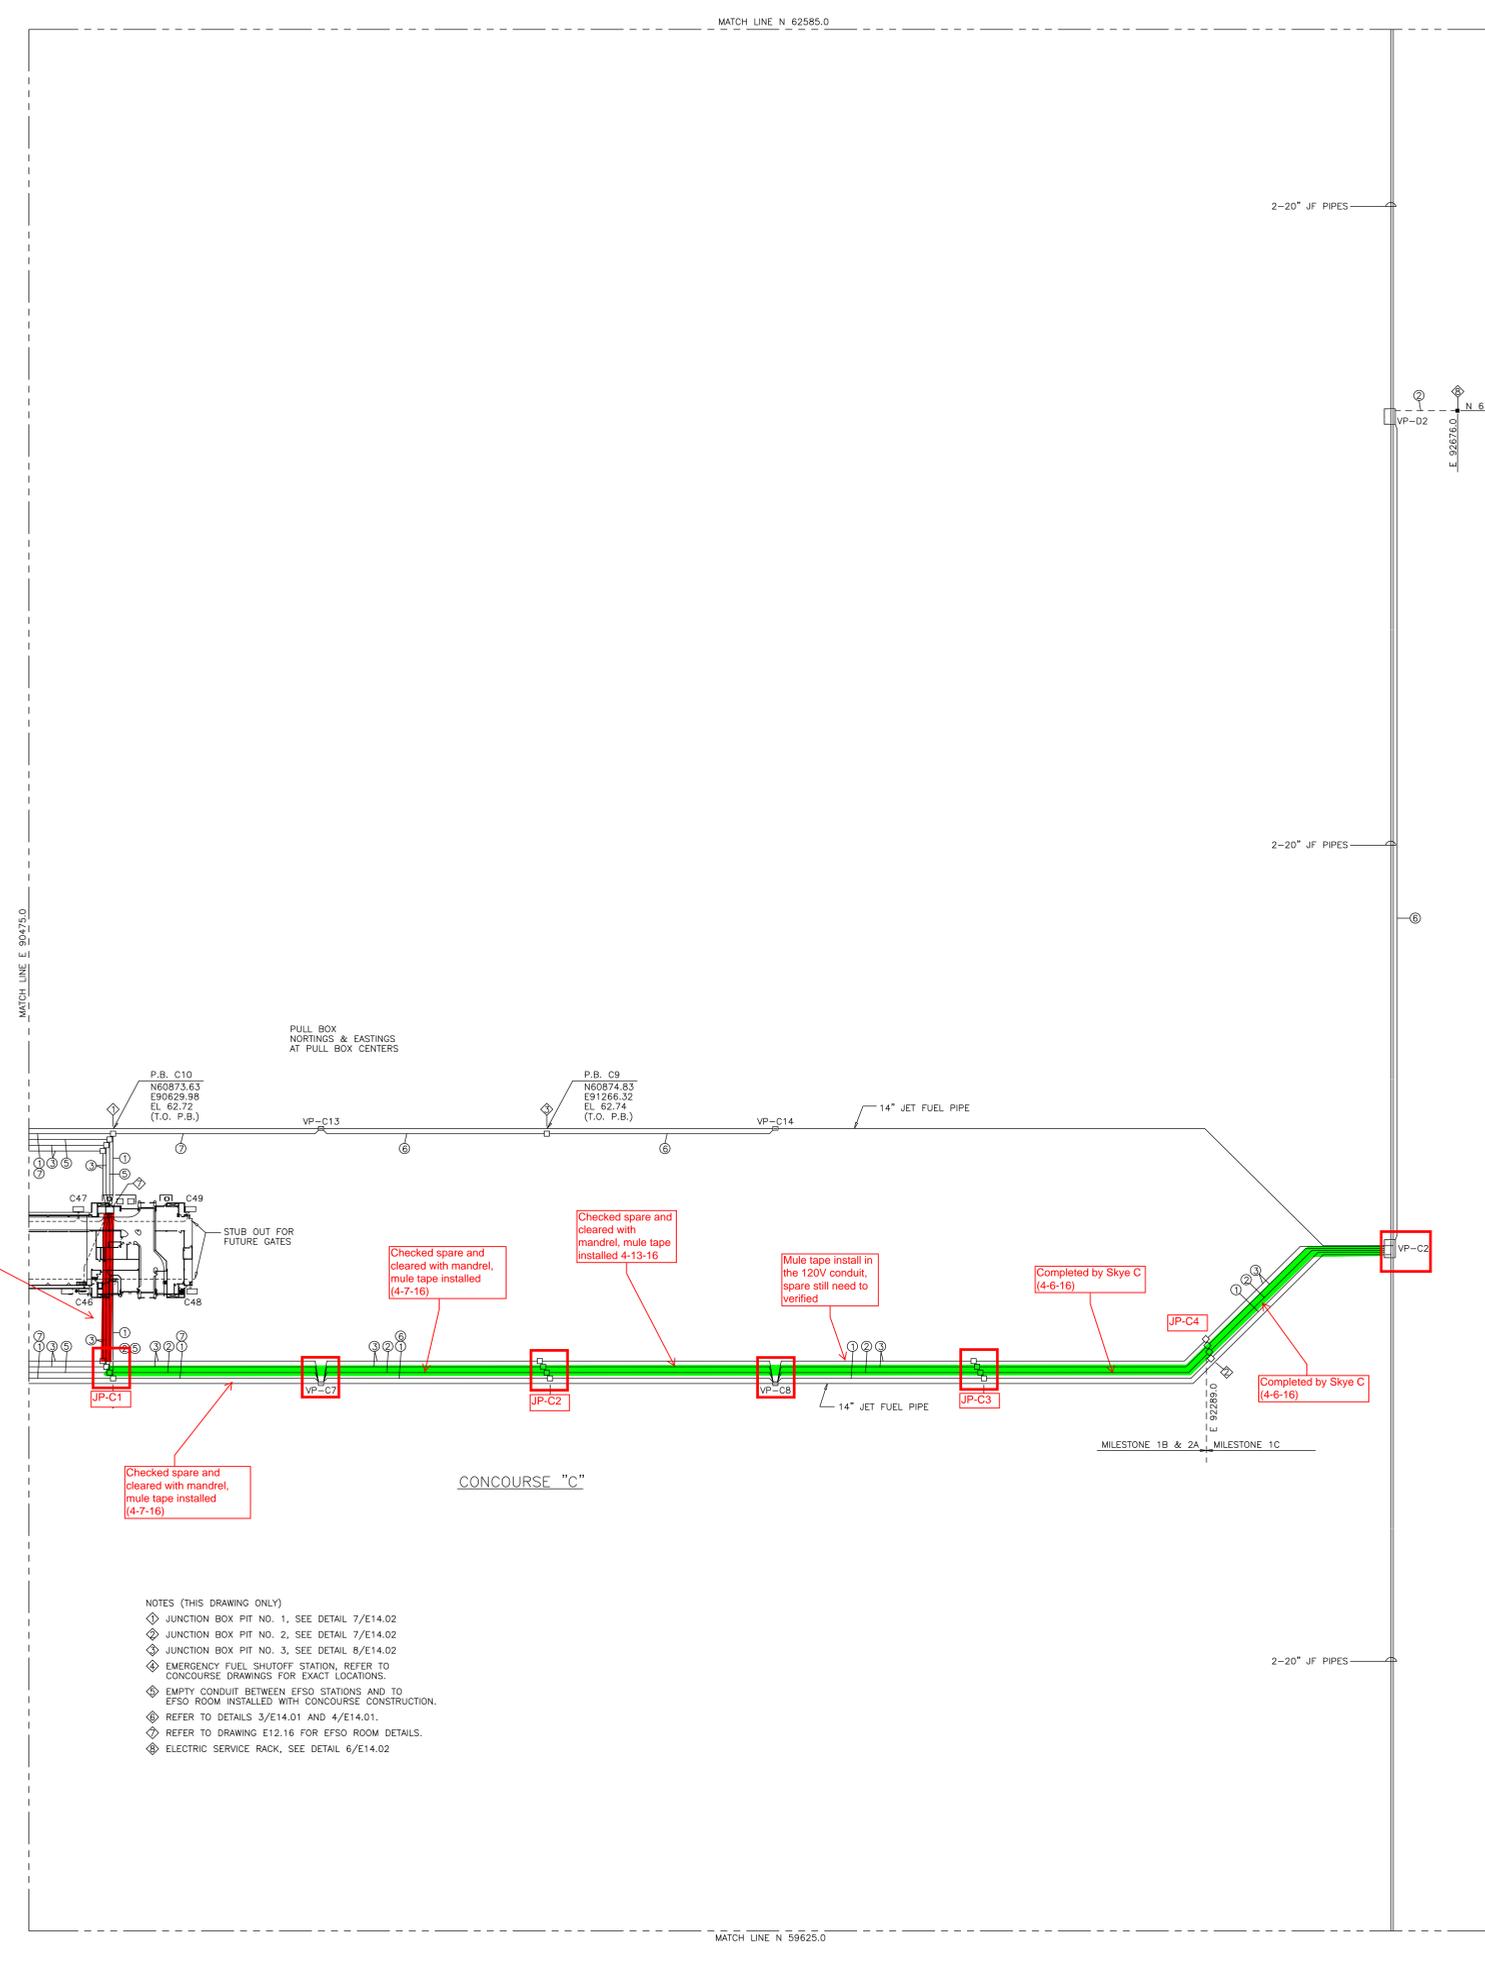
Couldn't get fish wire thru spare, when feeding from the EFSO room, the fish wire hits something that is along the path (4-7-16) need about 2 hours  
Tracked conduit in basement, no junction box. Fished camera through conduit, 1st from the electrical pit, at about 53ft the camera hits something in the conduit (conduit full of water at this point) but camera passes through. At about 95 ft, there is a blockage, appears to be mud in the conduit, assume conduit is broken, next fished camera from the EFSO, about 4ft there is something in the conduit that would not allow the camera to pass. object appeared to be square. (4-20-16).

what is the recommended remedy?  
BLB - to replace the conduit outside and no recommendation for the inside.
